Manhole Inspection Summary

Manhole # S09II1010MH

Insp Date: **1/12/09 2:09 PM**

Location Address: **4600 WABASH AVE**

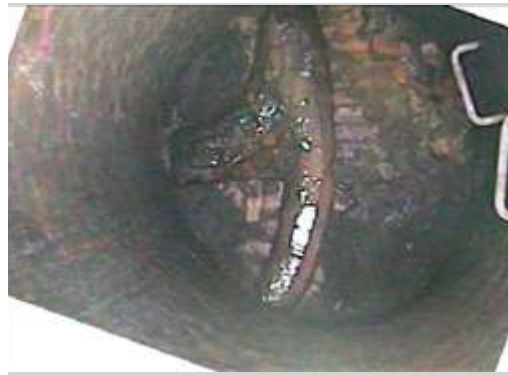
Top View

DEBRIS ON BENCH

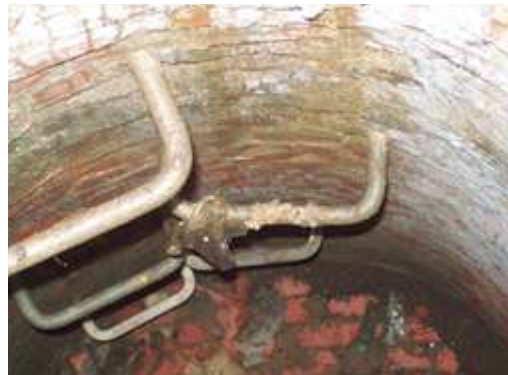
Defect 3

☒ **Evidence Of Surcharge** Depth: **8** (ft.) ☐ Active Surcharge Present

EVIDENCE SURCHARGE

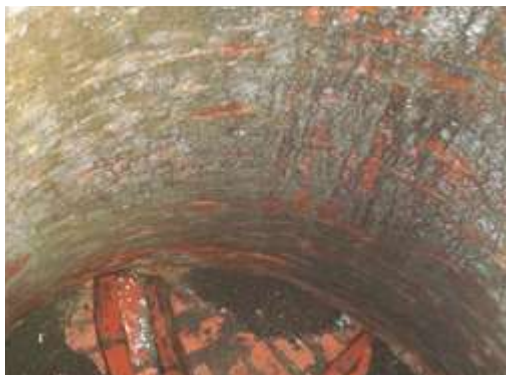
Defect 2

Infiltration: ☐ None ☐ Joint ☐ Cracks ☐ Mortar ☐ Roots ☒ **Wall**

INFILTRATION BARREL

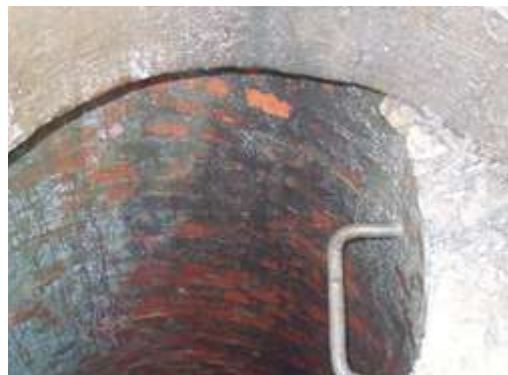
Defect 1

Infiltration: ☐ None ☐ Joint ☐ Cracks ☐ Mortar ☐ Roots ☒ **Wall**

INFILTRATION CORBEL

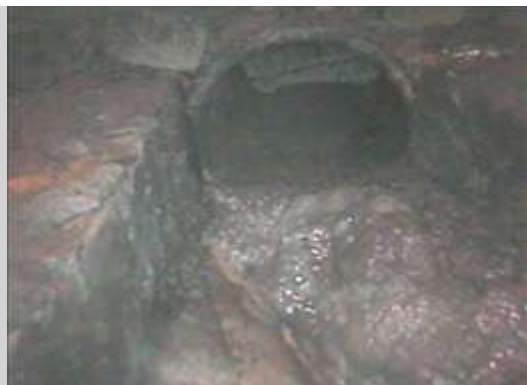
9 O'Clock Inflow

Deposits: ☐ None ☒ **Mud** ☒ **Sludge** ☐ Debris ☐ Grease

Silt Depth: **0** (in.) Deposits Extent: **Light**

Connects To: **Stub connection / abandoned**
